PART I: SEPTEMBER 11, 2001

Chapter 1

NEW YORK CITY'S WORLD TRADE CENTER

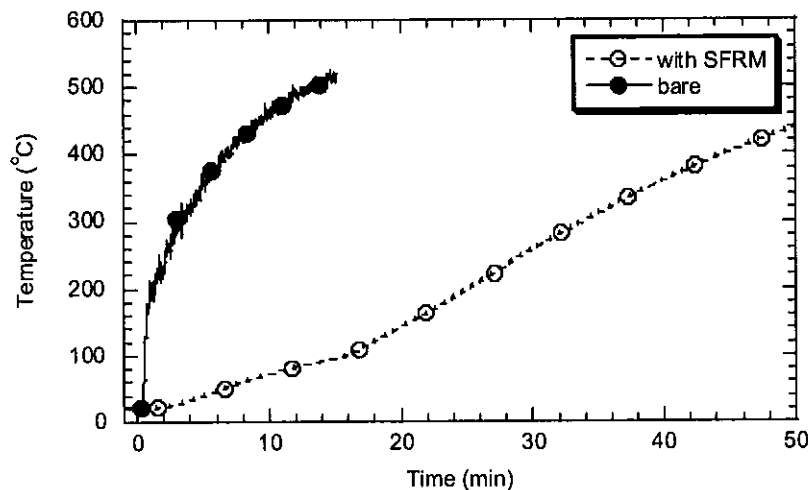
The perimeter columns, floors, and core columns were immersed in these hot gases and began to weaken. Where the insulation was dislodged, the temperature of the steel rose rapidly, in contrast to steel members where insulation was intact (Figure 2–8). The heaviest core columns with damaged insulation heated slowly, as the absorbed heat was dissipated through their massive cross sections. The temperatures of the lighter columns and the floor slabs rose more quickly, and those of the stripped trusses even more so.

Figure 2–8. Steel surface temperatures on the bottom chords of fire-exposed trusses, uninsulated and insulated with ¾ in. of BLAZE-SHIELD DC/F.

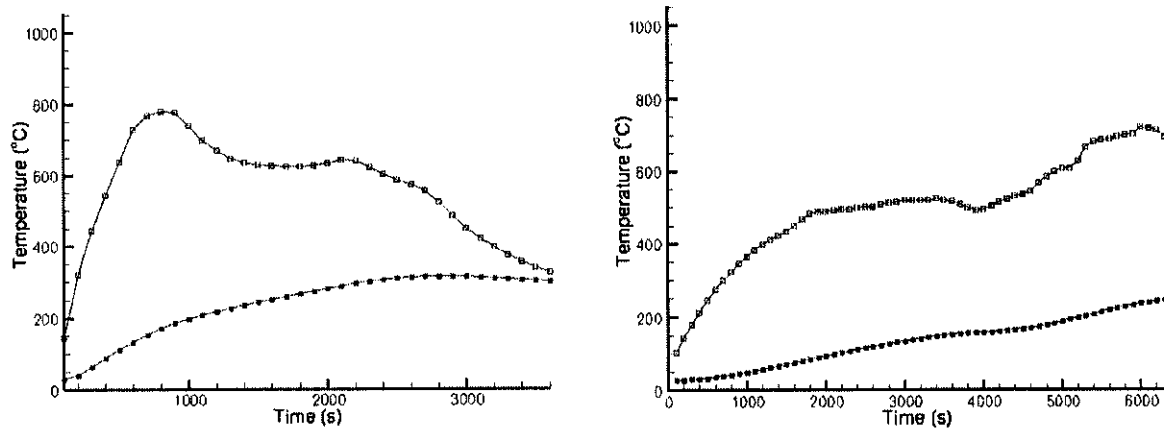
Note: The red data are for structural steel components without insulation; the blue data are for steel components that are still insulated.

Figure 2-10. Simulated temperatures of two adjacent trusses (left) and two adjacent perimeter columns (right) exposed to the fires in WTC 1.
